## *Spray Applied Erosion Resistant Coating Belzona 1381 for*

# ***Elevated Temperature Services***

## Belzona 1381 Case Study

*Belzona Protects A Rig Caisson Suffering From Internal Erosion-Corrosion*

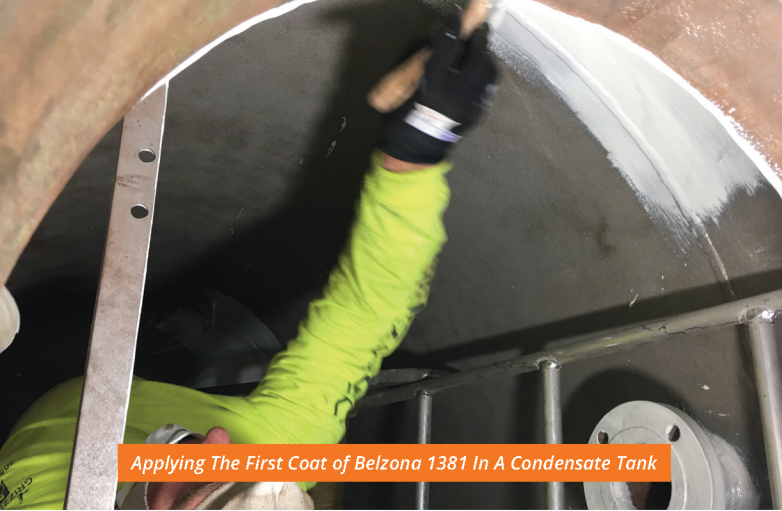
*Applying The First Coat of Belzona 1381 In A Condensate Tank*

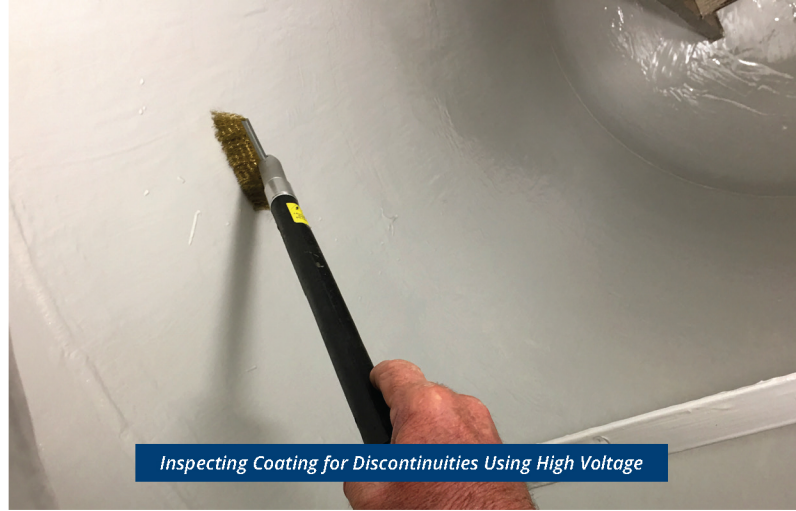
*Inspecting Coating for Discontinuities Using High Voltage*

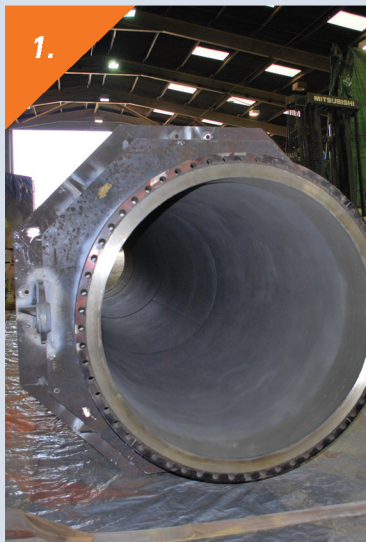
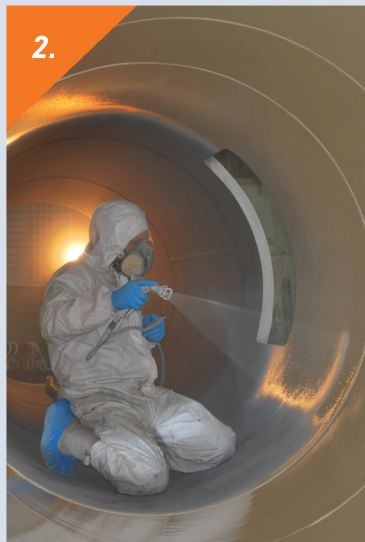
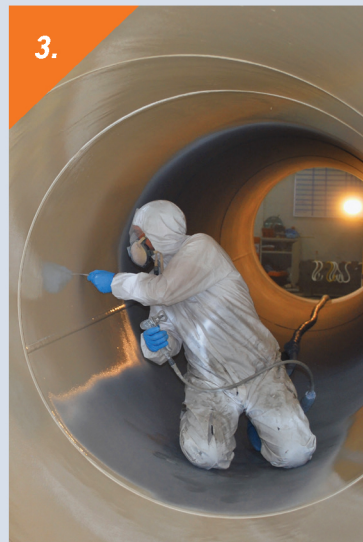
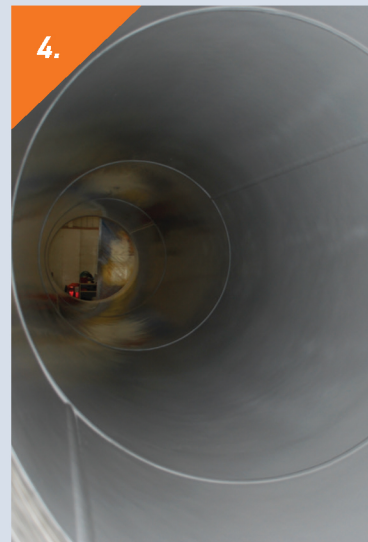
1. Grit blasted caisson
2. Spray application in progress
3. Wet film thickness being measured
4. Completed application

*This caisson was lined with a glass flake coating which had failed. The local H&S authority had requested a replacement of the caisson, or the rig had to be shut down. Given the short notice to carry out the work, metal cladding of the caisson was not an option. Glass flake technology had failed. The customer needed a sprayable and erosion-resistance solution: 750 L of Belzona 1381 were used for this purpose.*
