# MAINTAINING ASSET INTEGRITY IN THE WATER AND WASTEWATER INDUSTRY

Belzona Protective Coatings and Engineering Composites

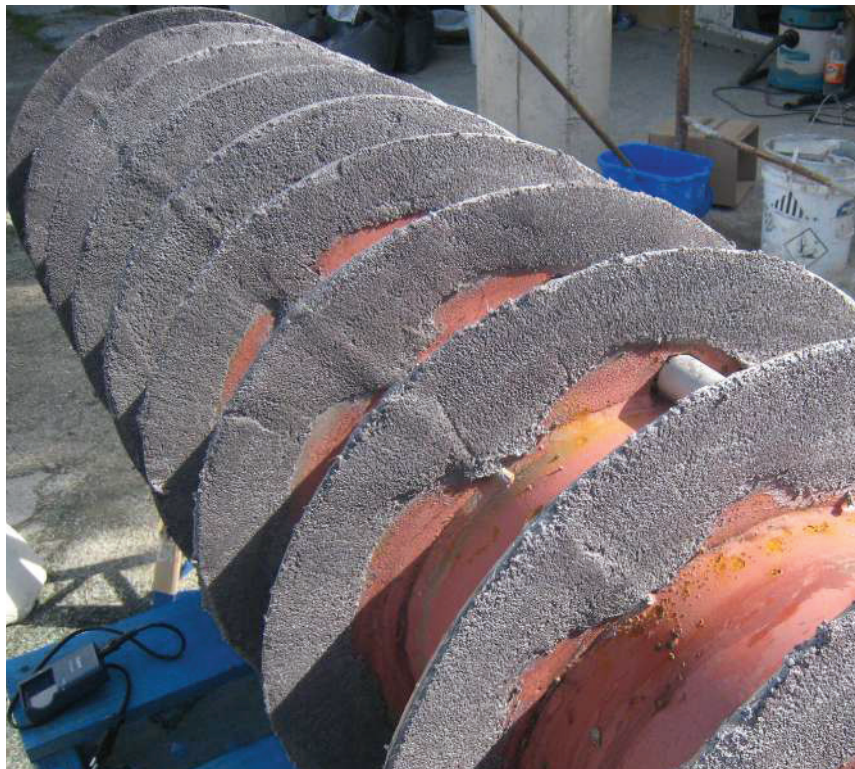
*Belzona abrasion resistant coating extends the life of screw conveyor*

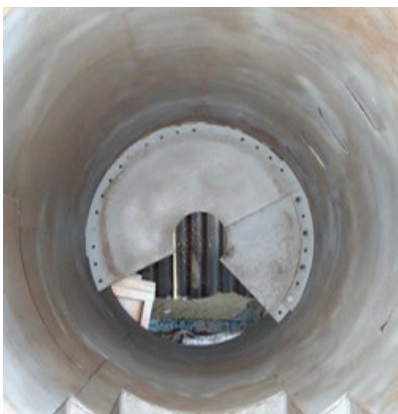
*Thin-wall defects on mixer*

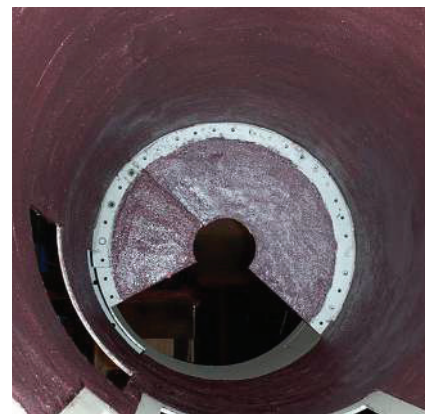
*Rebuilt and protected against abrasion*

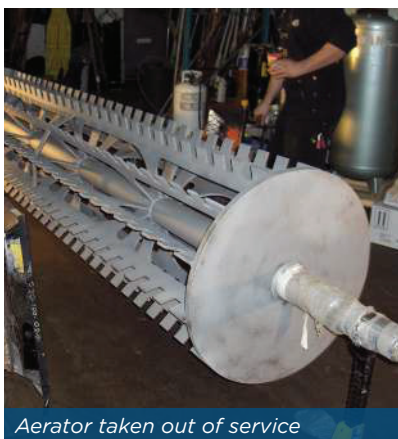
*Aerator taken out of service*

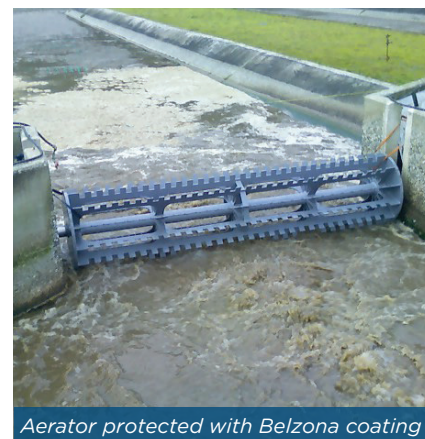
*Aerator protected with Belzona coating*

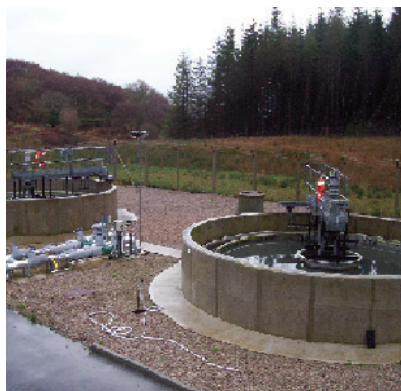
*Impact and abrasion damage to concrete clarifiers*

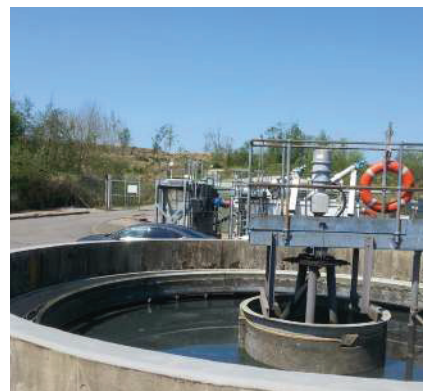
*Clarifier rebuilt with Belzona materials providing chemical and impact resistance*

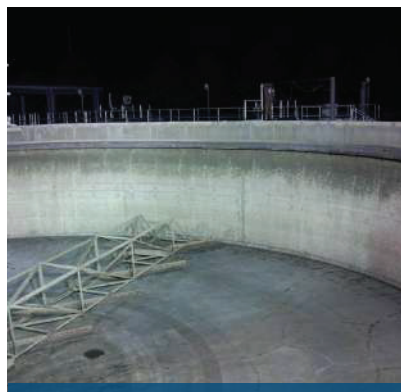
*Hard to clean, damaged concrete trough*

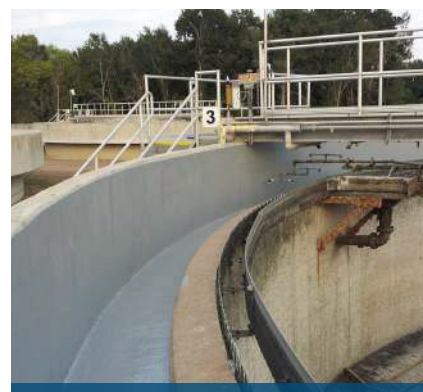
*Clarifier rebuild and coated with Belzona materials*

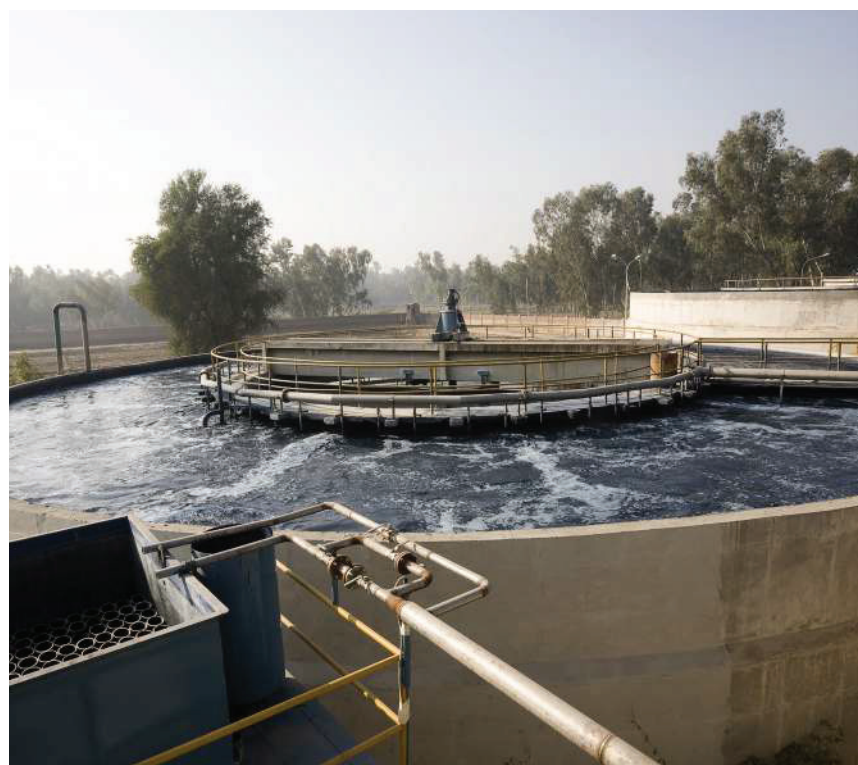
*Clarifier repairs completed*

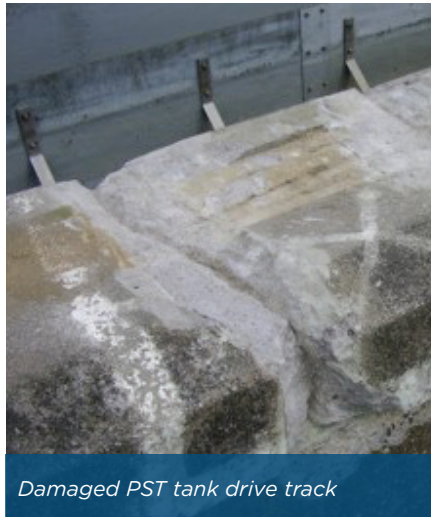
*Damaged PST tank drive track*

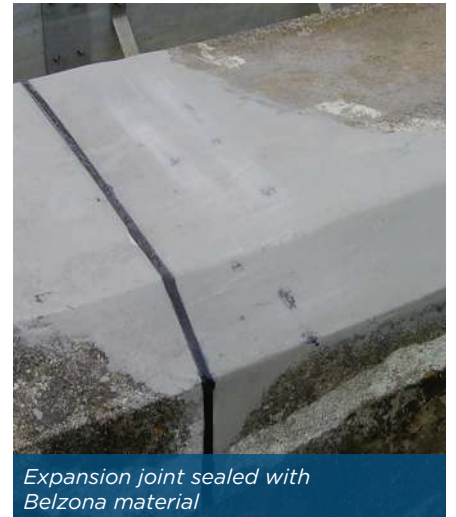
*Expansion joint sealed with Belzona material*

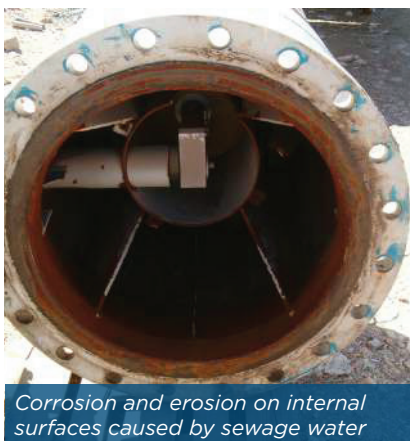
*Corrosion and erosion on internal surfaces caused by sewage water*

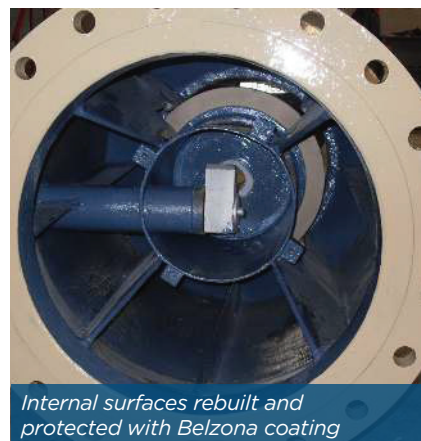
*Internal surfaces rebuilt and protected with Belzona coating*

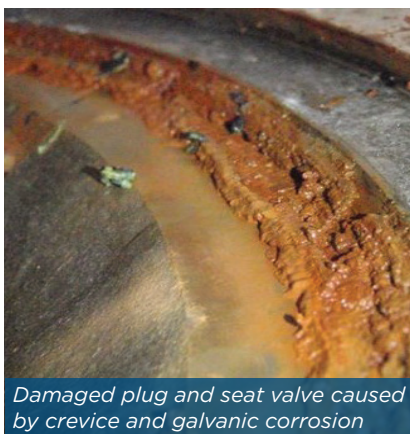
*Damaged plug and seat valve caused by crevice and galvanic corrosion*

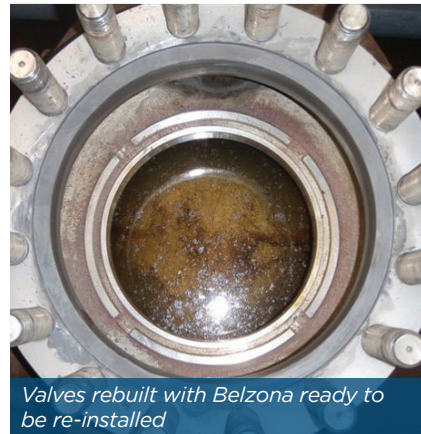
*Valves rebuilt with Belzona ready to be re-installed*

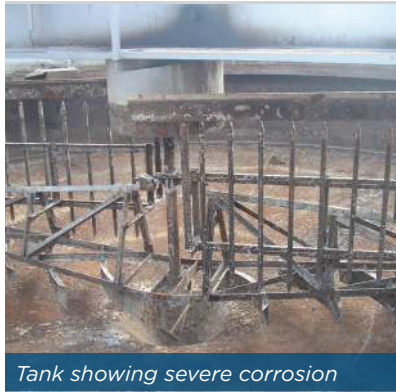
*Tank showing severe corrosion*

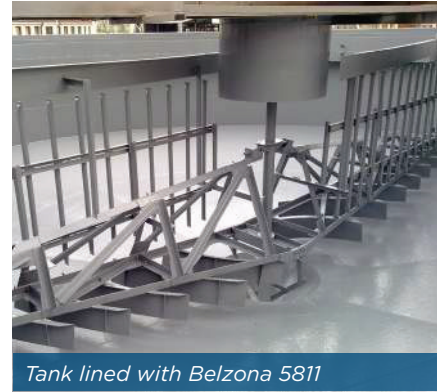
*Tank lined with Belzona 5811*

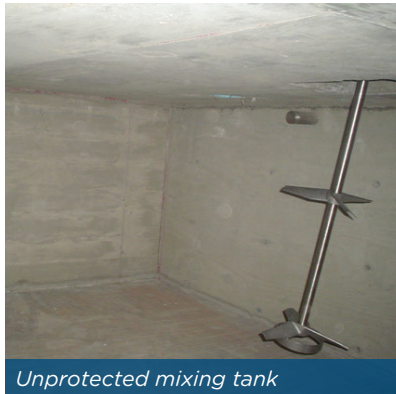
*Unprotected mixing tank*

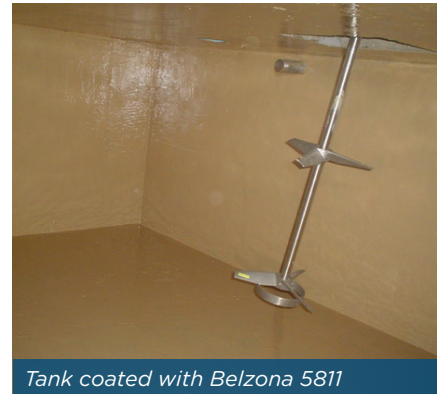
*Tank coated with Belzona 5811*

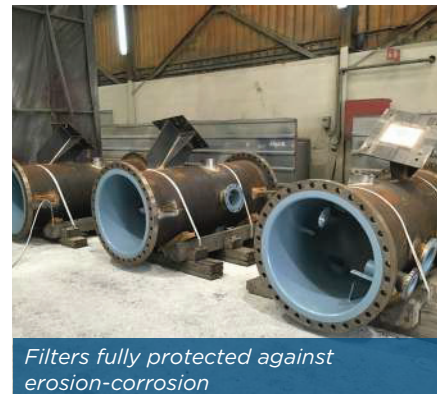
*Filters fully protected against erosion-corrosion*

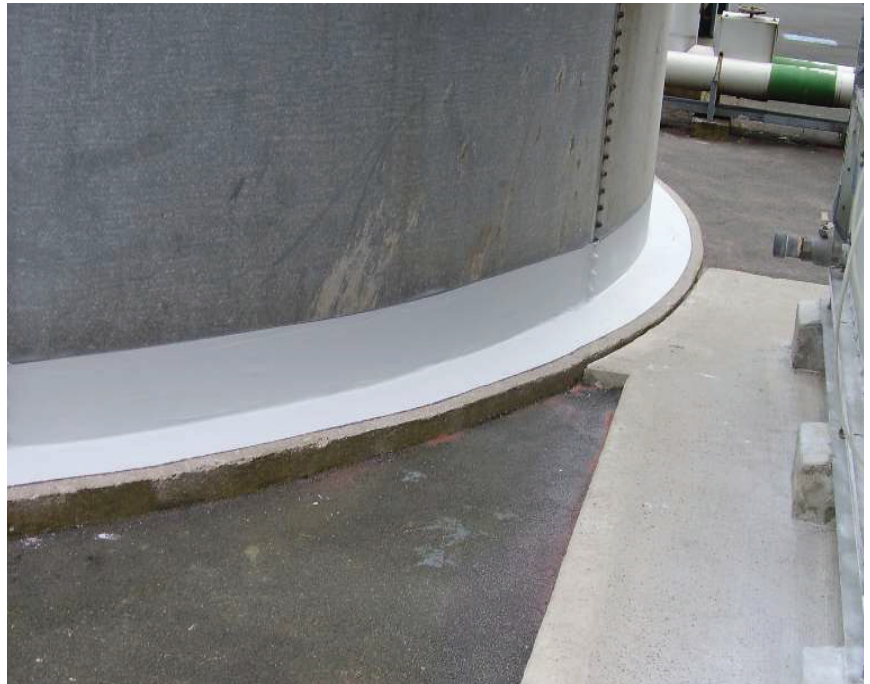
*Belzona lining applied to a newly fabricated process vessel*

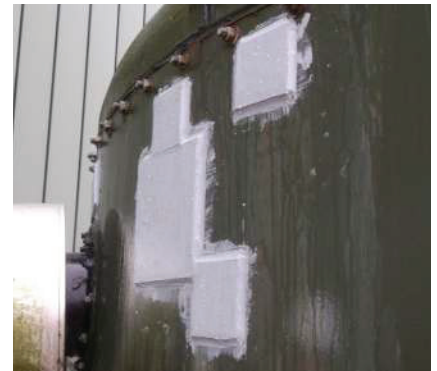
*Tank repaired by cold bonding*

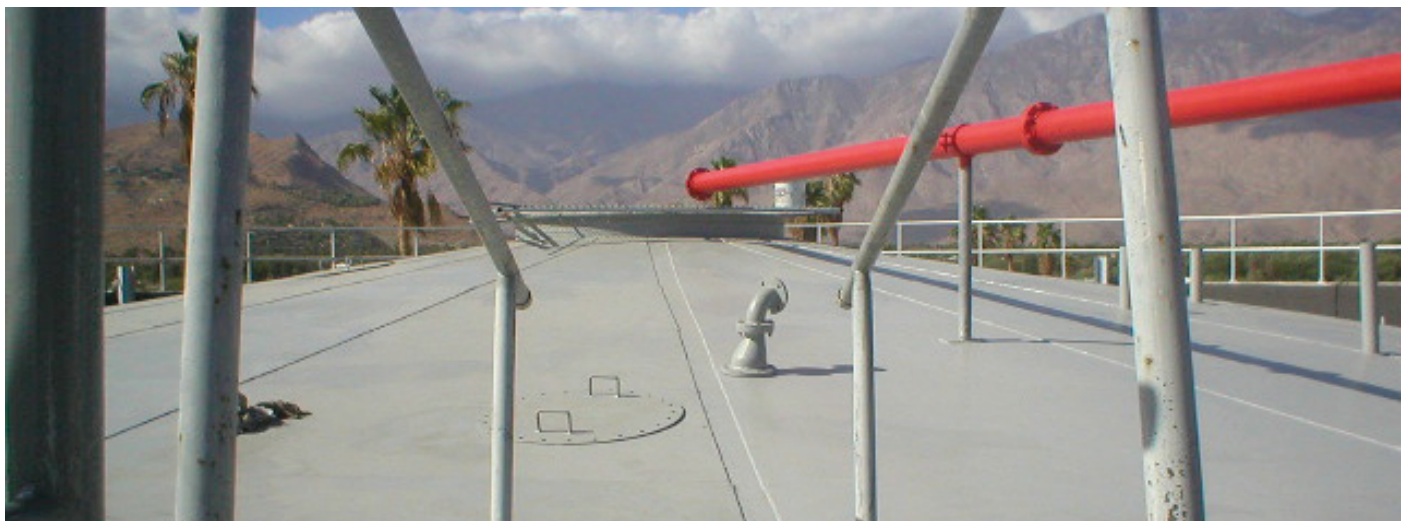
*Tank roof restored with a Belzona protective coating*

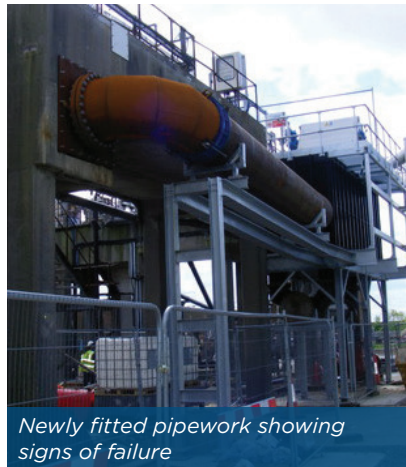
*Newly fitted pipework showing signs of failure*

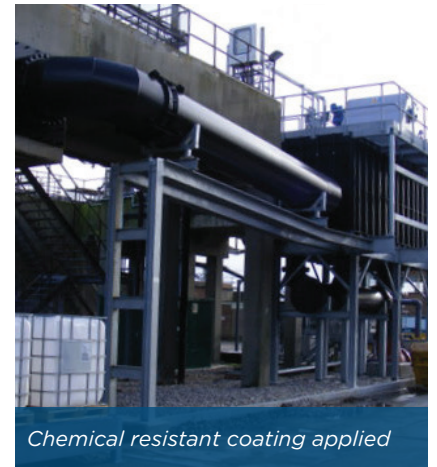
*Chemical resistant coating applied*

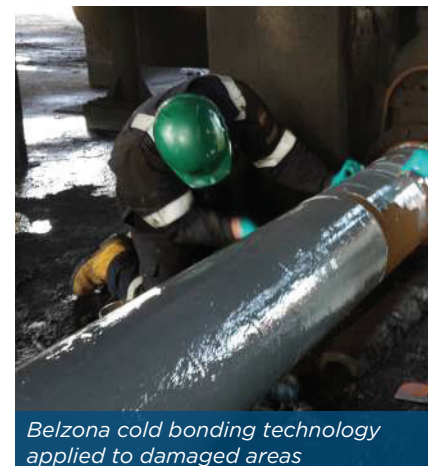
*Belzona cold bonding technology applied to damaged areas*

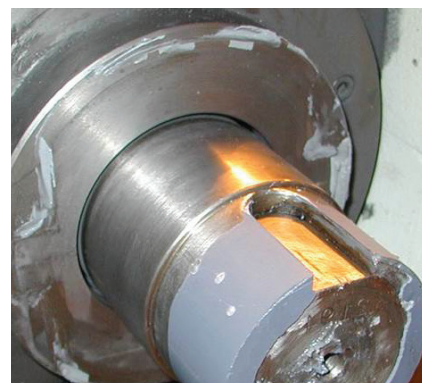
*Keyway housing and shaft repaired with Belzona material*

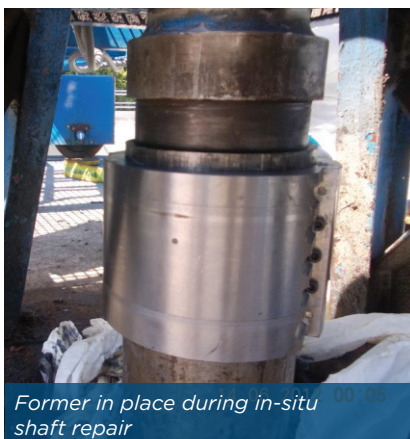
*Former in place during in-situ shaft repair*

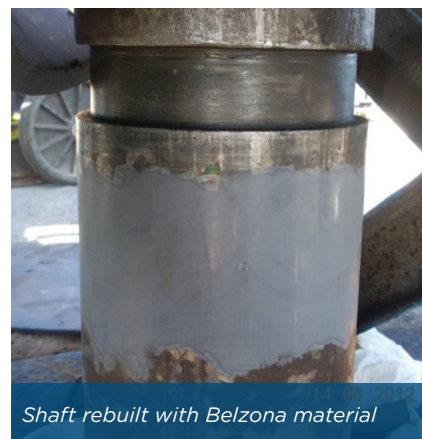
*Shaft rebuilt with Belzona material*

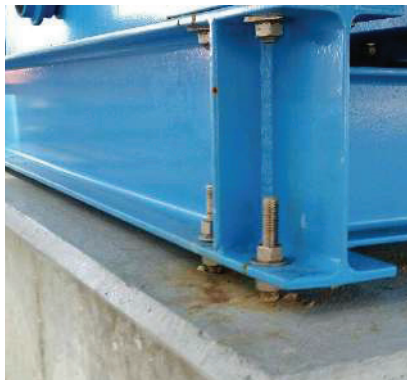
*Newly installed equipment requiring chocking*

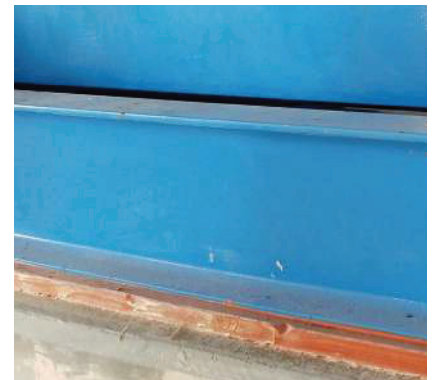
*Belzona 100% solids chocking compound applied*

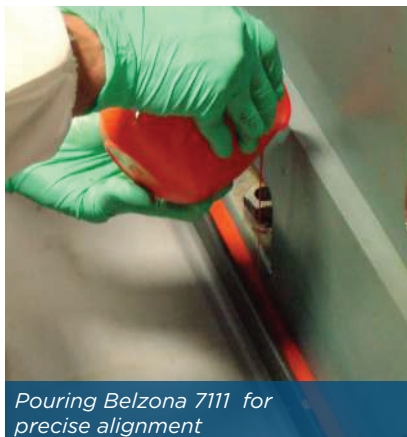
*Pouring Belzona 7111 for precise alignment*

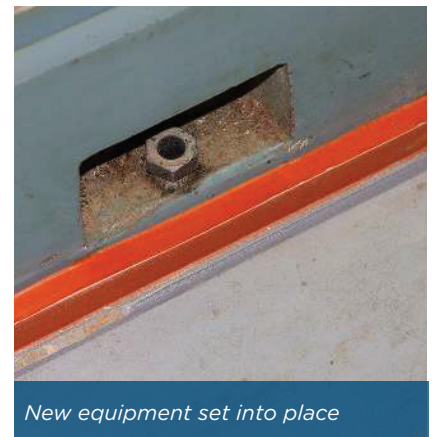
*New equipment set into place*
