# Belzona Flange Face Forming - Protection for Critical Assets

# Belzona Know-How *in Action*

KHIA ID: 9190

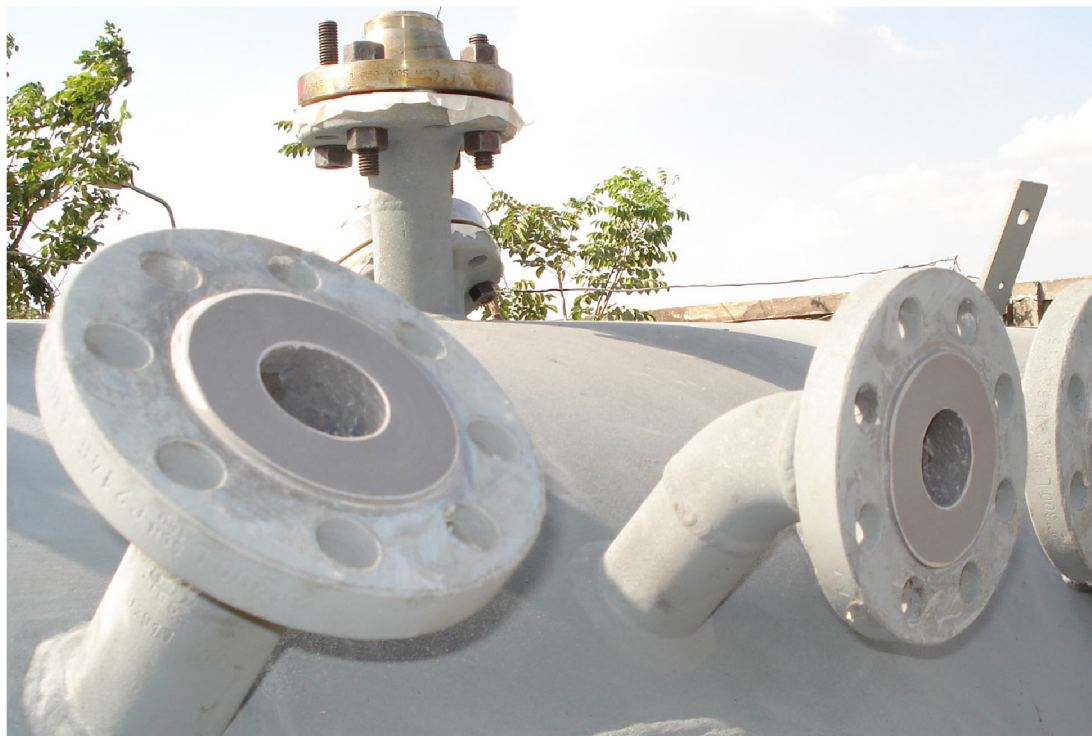
Trapped corrosives in flange gaps can quickly attack faces and gaskets, leading to leaks and potential system failure. Without protection, even minor corrosion can escalate into catastrophic damage.

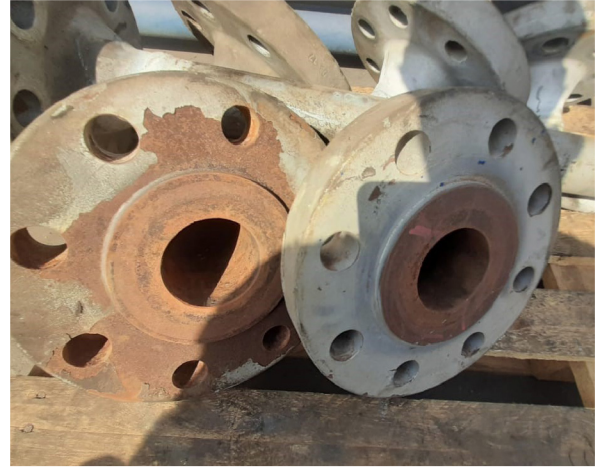
An international oilfield services contractor was experiencing severe corrosion and leakage on a number of flange faces. Traditional welding based repair methods were ruled out due to strict safety requirements and concerns over long-term reliability.

*Initial condition of flanges*

The flange faces were grit blasted to Sa 2.5 with a with a 75 µm (3 mils) profile before a dimension-matched former was prepared and treated with Belzona 9411 (Release Agent).

Belzona 1111 (Super Metal) was then applied to both the flange face and the released former. Using a Belzona applicator cut to a V-shaped contour, the paste-grade material was built up across the flange face to form a high peak along the centre line. The flange and former were bolted together and left to cure in accordance with the IFU.

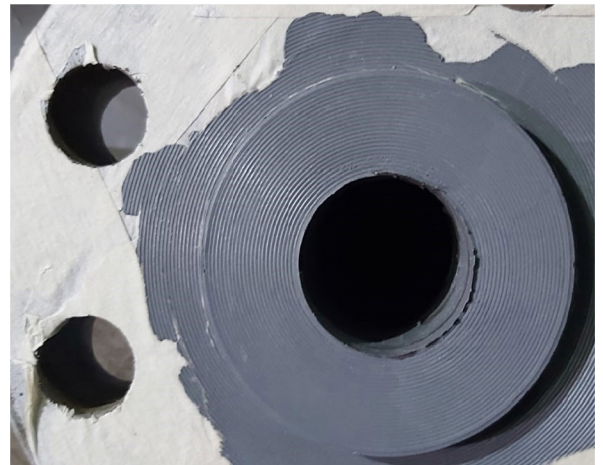
*Flange faces rebuilt and restored with Belzona 1111 (Super Metal) using forming technique*

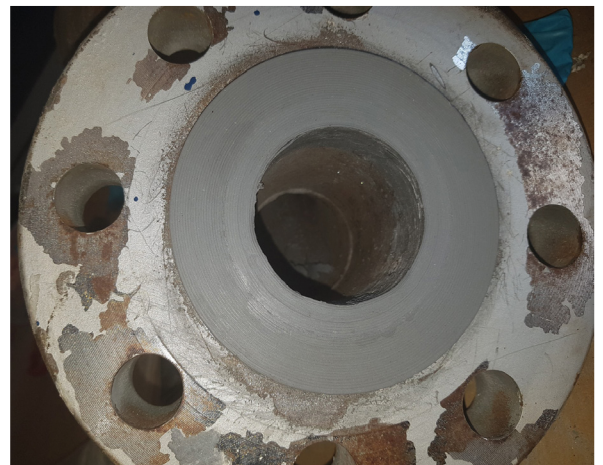
*Completed flange face forming repair*

Upon removal of the former, the required serration pattern was achieved on the flange face, as specified by the customer. Belzona flange face forming was selected for its rapid installation and convenience, enabling the customer to avoid unnecessary downtime. In addition, the solution provides long-term protection against further corrosion.
