# PUMP SYSTEMS

*Belzona Engineering Composites  
and Protective Coatings*

# Belzona Solutions for Pump Systems

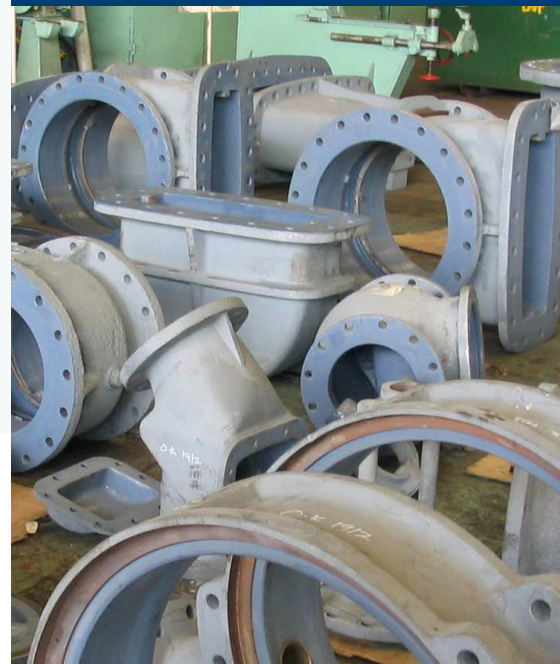
Erosion-corrosion protection and efficiency enhancement

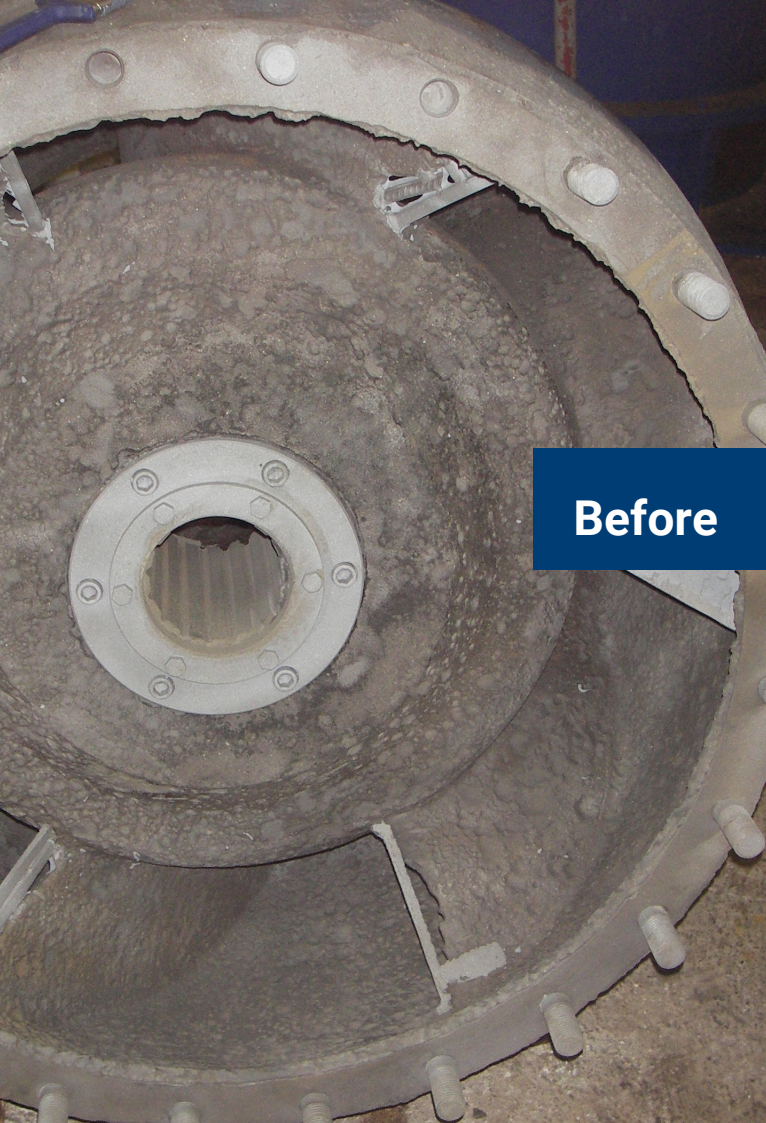
**Before**

Pitting, worn wear ring clearances, eroded cutwater profiles and water ring seals on end casings, as well as thin- and through-wall casing defects, are issues commonly addressed by Belzona's range of cold-applied paste grade composites, which will:

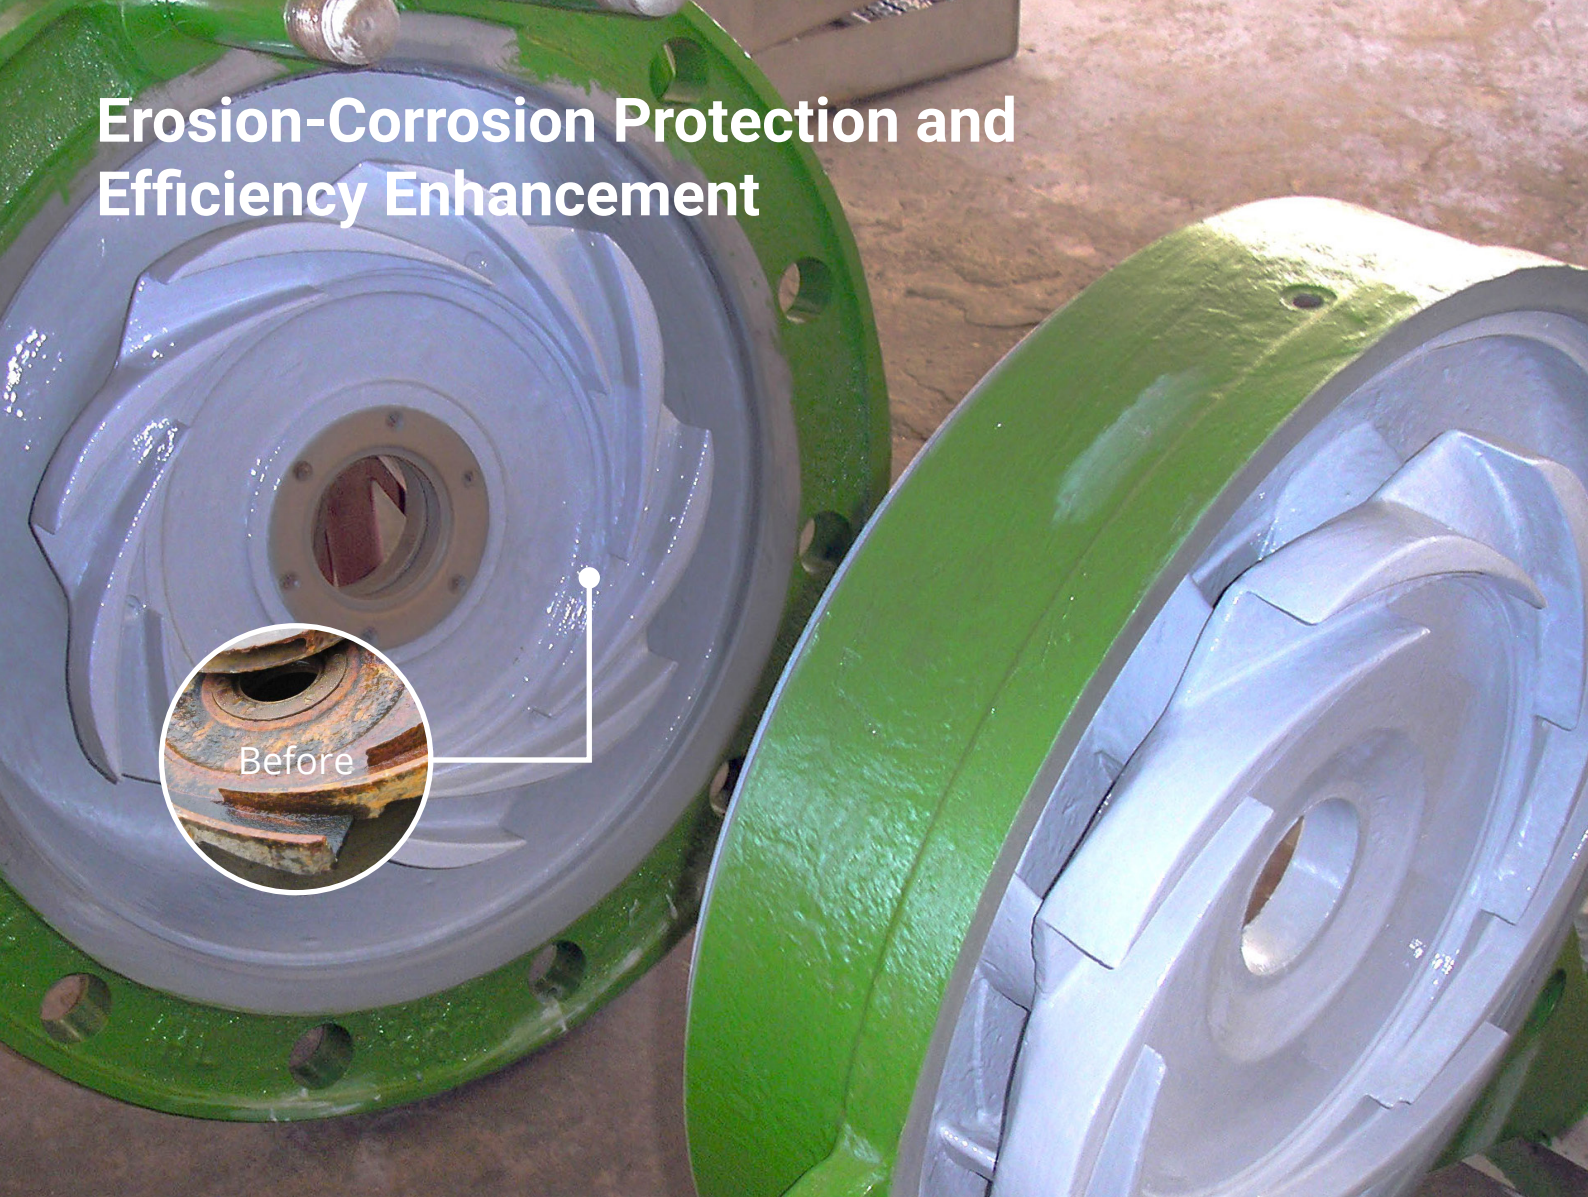
Before

## Polymeric Coatings for Long-Term Protection

The physical and mechanical problems that affect fluid handling equipment are directly linked to poor efficiency or performance. In fluid flow situations, isolating the metal surface from its environment is the only way to significantly reduce the effects of erosion-corrosion.

This can be achieved by the application of a protective coating to the pump internal components. Protecting pumping systems with erosion-corrosion resistant coatings helps to reduce the loss of performance, significantly extend maintenance free periods and prolong the pump's service life.
