# Abrasion Resistant Materials for Long Term Protection

## Turbo Separator Repair With Belzona 1818

**Elite KHIA**

KHIA ID: 8480

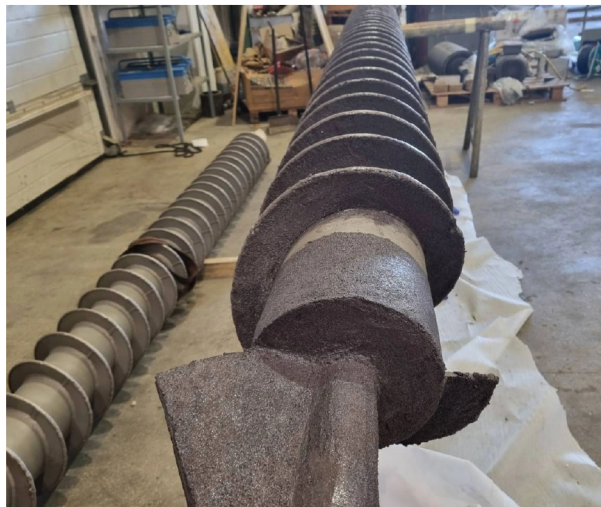
*Screw conveyor from the cement industry protected with Belzona.*

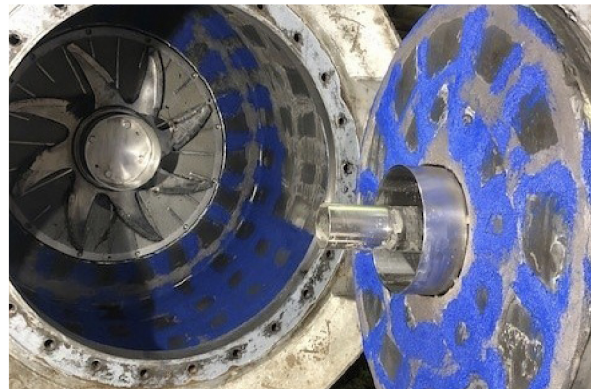
*Application complete*

After removing the pulp, the turbo separator was dried using rags. Surface preparation was completed quickly with a diamond blade on an angle grinder, ensuring the ideal surface profile for Belzona 1818. The product was easily mixed and applied, even in difficult overhead areas, providing a seamless repair. With its ability to adhere to vertical and overhead surfaces, minimal surface preparation requirements, and fast curing properties, Belzona 1818 allowed for a quicker return to service, reducing both downtime and costs.
