# Elastomeric Solutions for Conveyor Repairs

## Conveyor Belt Repair Saved Coal Terminal Money and Downtime

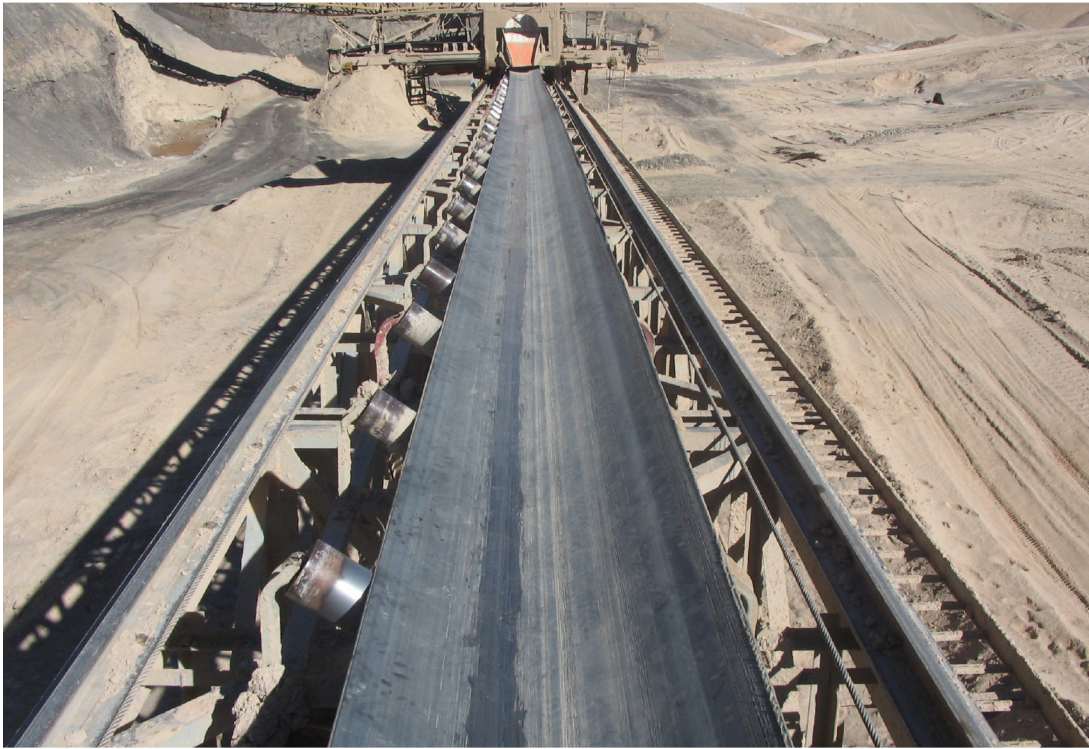
Conveyor belts constantly work under the demanding conditions of the mining environment, where the weight and abrasiveness of materials cause rips, tears, holes and slits.

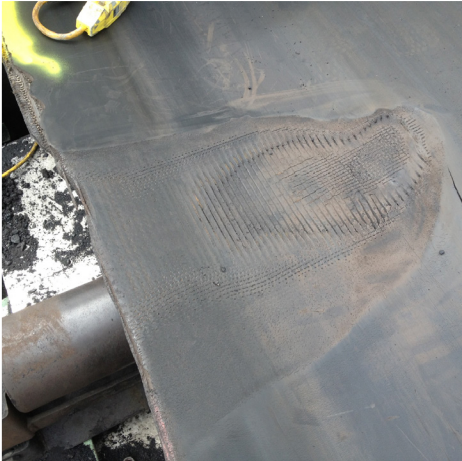
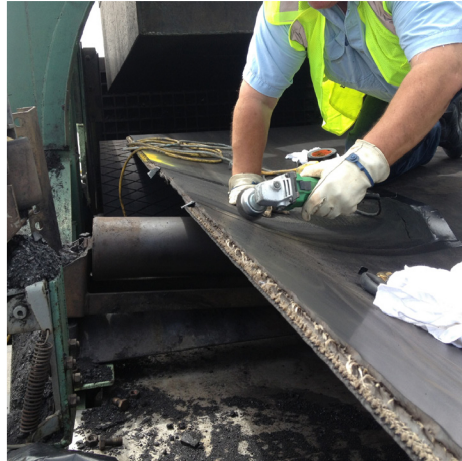
KHIA ID: 5286

This conveyor system had to be ready for use the following Saturday, however the coal conveyor belt had got caught on the roller and as a result, "burnt" the belt. The customer could not wait for a vulcanized repair so Belzona was contacted to see if problem could be remediated using one a Belzona 2000 Series product.

The outage of the conveyor belt would have cost the customer \$2000 per day therefore they needed an immediate solution. The belt was prepared using grinder and roughing brush. Belzona 2111 (D&A Hi-Build Elastomer) was applied to surface, and a reinforcement sheet impregnated with Belzona 2121 (D&A Hi-Coat Elastomer) and placed across repair area. After one year in service the belt is still in use and the customer has since had additional conveyor belt repairs completed.
