# MAINTAINING ASSET INTEGRITY IN THE MARINE INDUSTRY

Belzona Protective Coatings and Engineering Composites

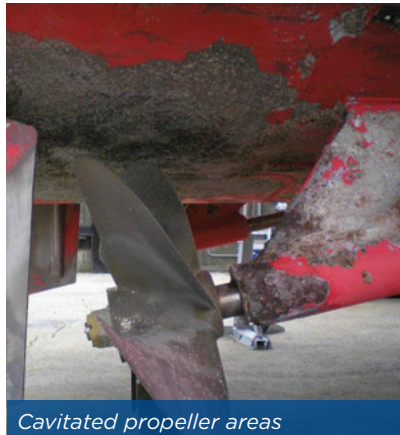
*Cavitated propeller areas*

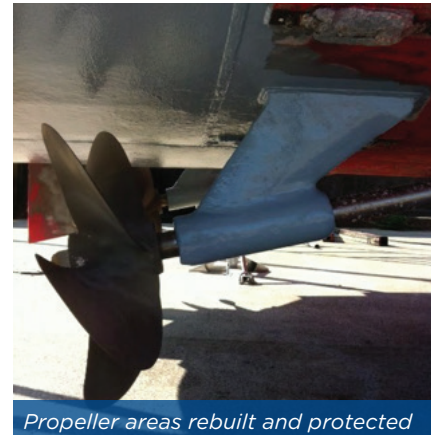
*Propeller areas rebuilt and protected*

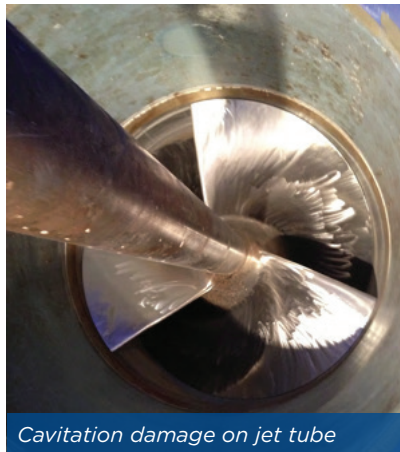
*Cavitation damage on jet tube*

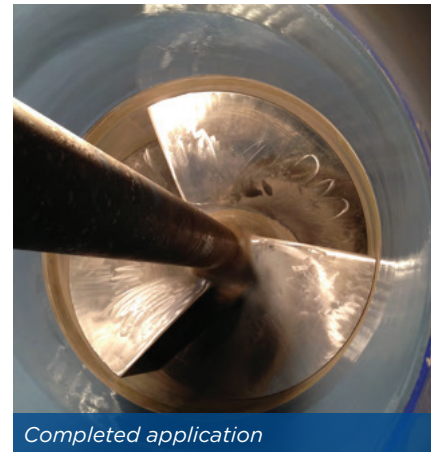
*Completed application*

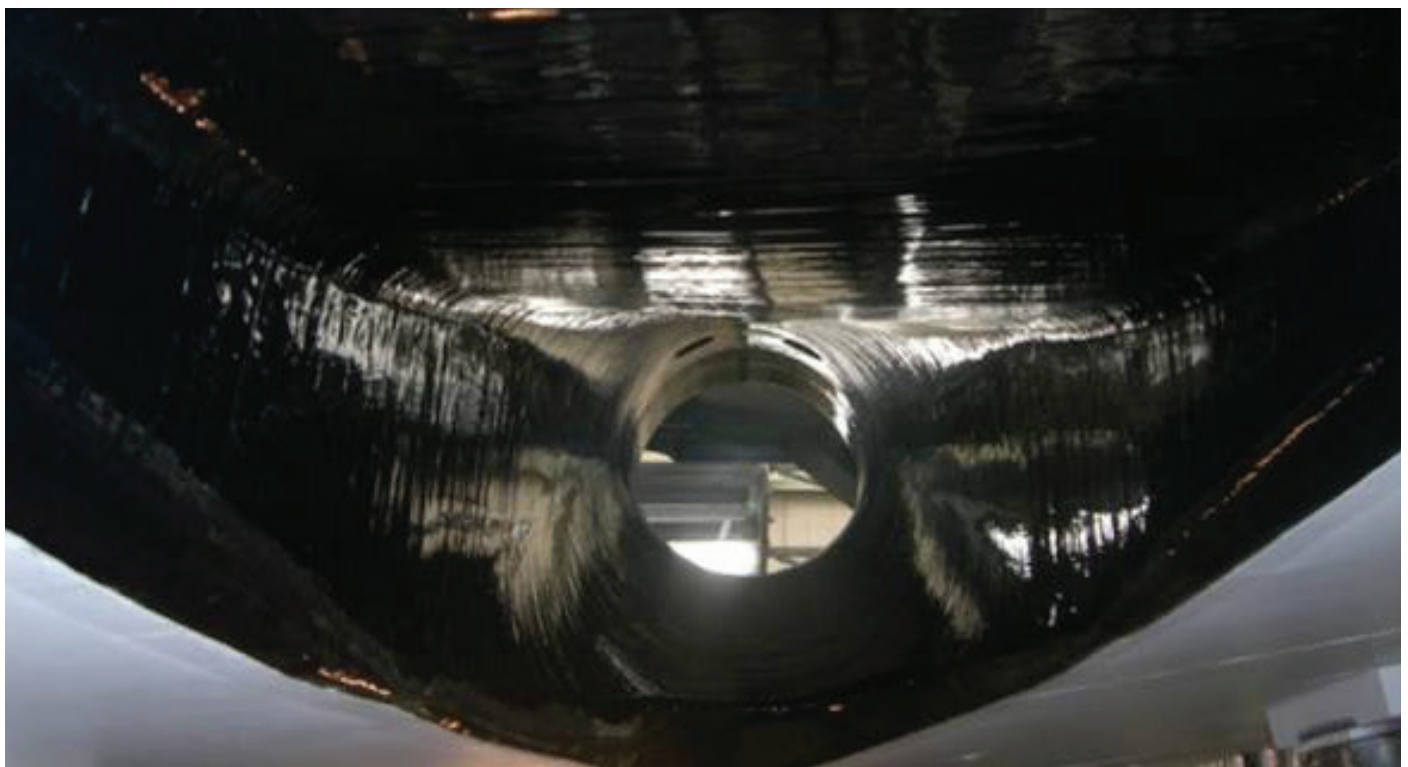
*Cavitation protection coating applied to jet tube area on super yacht*

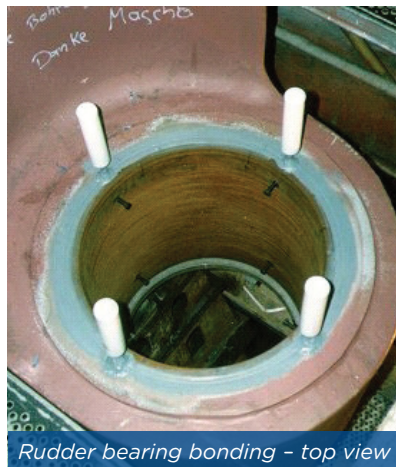
Rudder bearing bonding - top view

The critical requirement with rudder bearings relates to the bush retention in the housing. Corrosion and impact wear can result in the development of annular gaps between the housing and the bearing bush, resulting in a malfunctioning rudder and, consequently, costly repairs and loss of sea time.

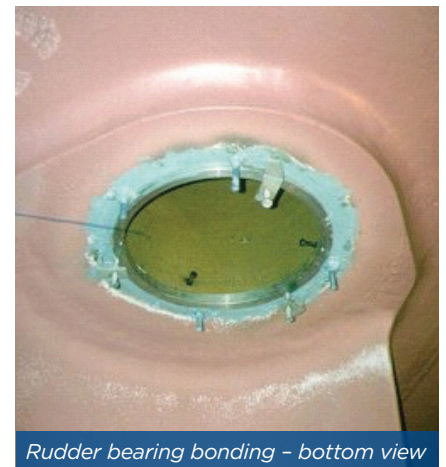
Rudder bearing bonding - bottom view

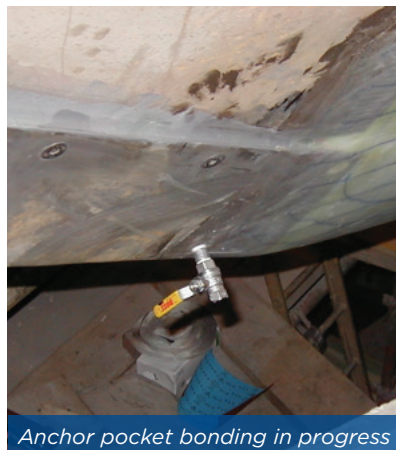
Anchor pocket bonding in progress

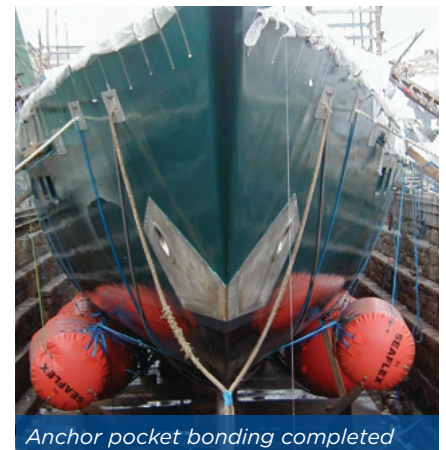
Anchor pocket bonding completed

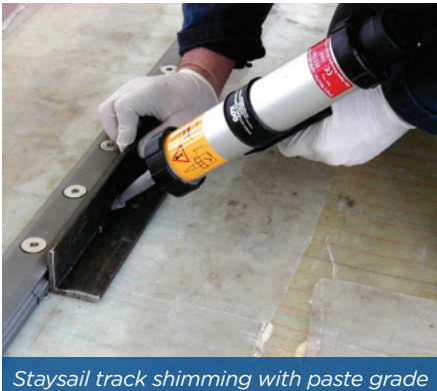
*Staysail track shimming with paste grade*

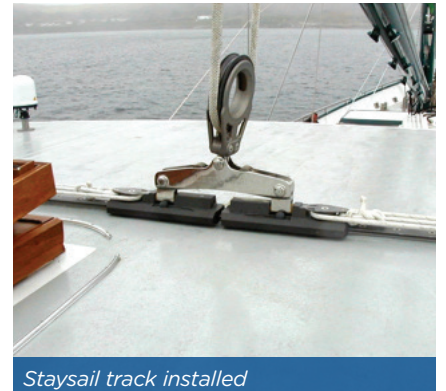
*Staysail track installed*

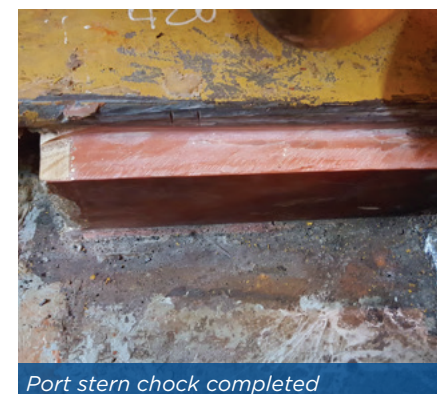
*Port stern chock completed*

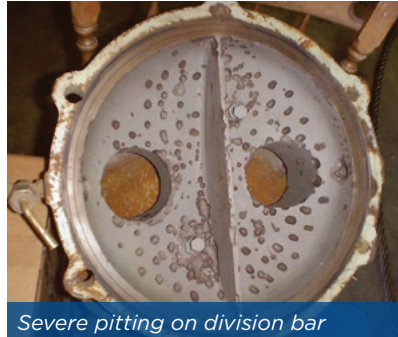
Severe pitting on division bar

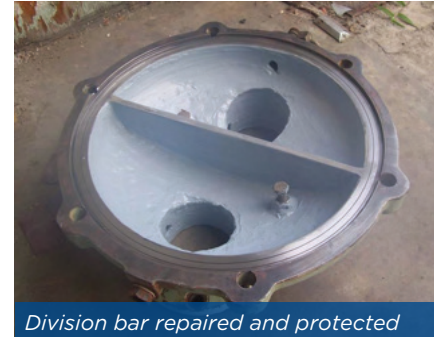
Division bar repaired and protected

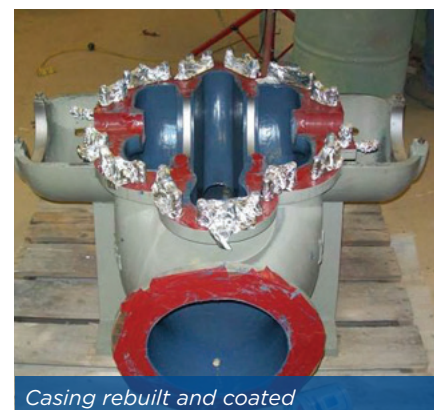
Casing rebuilt and coated

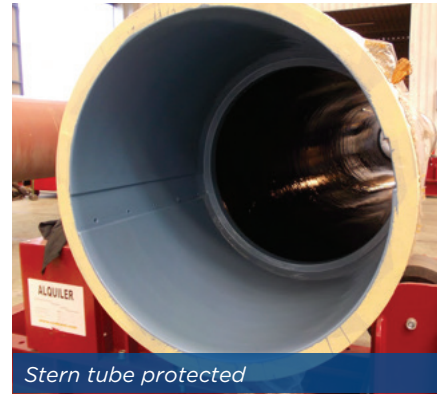
*Stern tube protected*

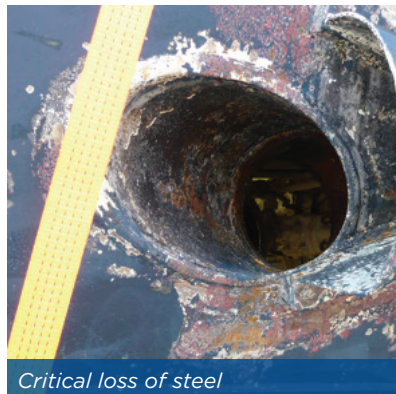
*Critical loss of steel*

Leisure boats with inboard engines often suffer from corrosion problems on the wet exhausts. The hot exhaust gas together with the salt water causes severe corrosion that can lead to critical loss of steel. High temperature resistant composite repair materials are used to recover the metal loss and rebuild the original surface profile of the water inlet and exhaust outlet. A high temperature lining can then be applied to provide long-term protection and eliminate future corrosion issues in the exhaust system.

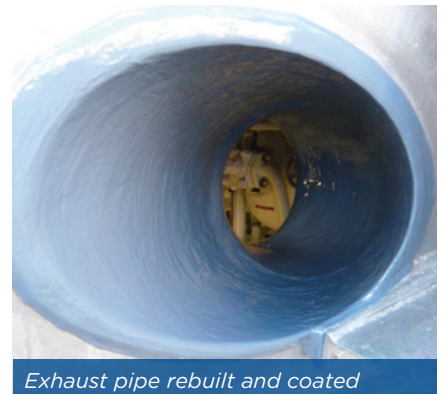
*Exhaust pipe rebuilt and coated*

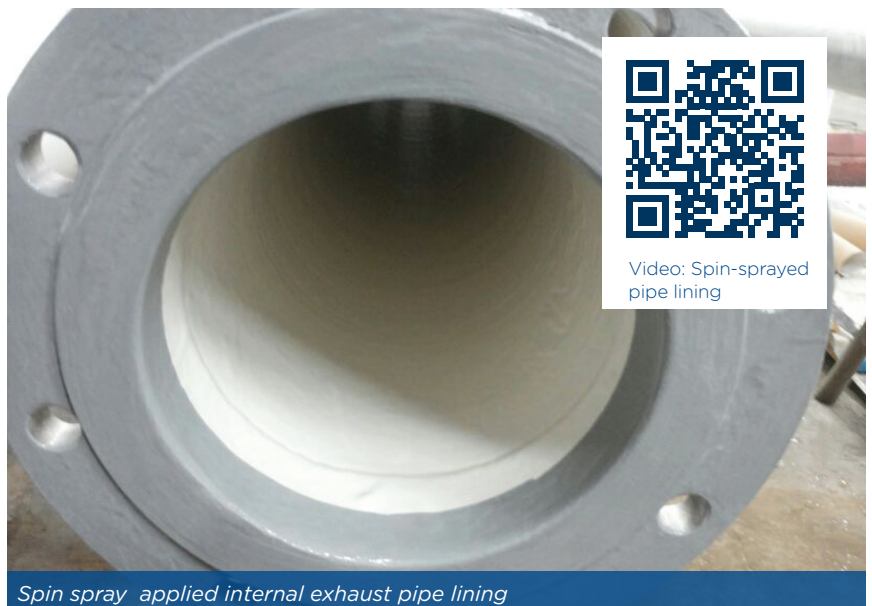
*Spin spray applied internal exhaust pipe lining*

Belzona pioneered a spray-friendly pipe lining system that offers erosion-corrosion protection from sea water and entrained solid particles such as sand. The substitution of hard ceramic fillers for a thermoplastic filler blend ensures there is very little wear to the spray equipment. The material can be spin spray or brush applied in situ at wet film thickness up to 1250 microns without sagging, effectively covering girth welds and joints in a single coat. The thermoplastic filler blend is formulated to achieve excellent impact and sliding abrasion resistance, a high degree of toughness and chemical resistance.

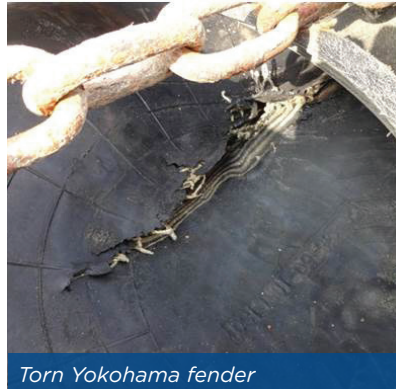
*Torn Yokohama fender*

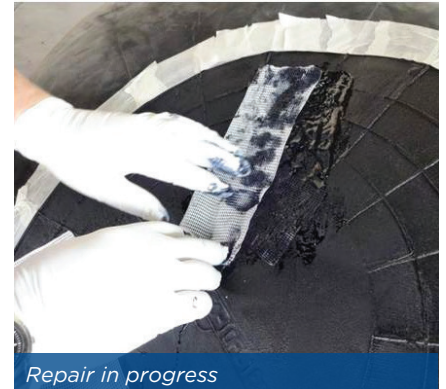
*Repair in progress*

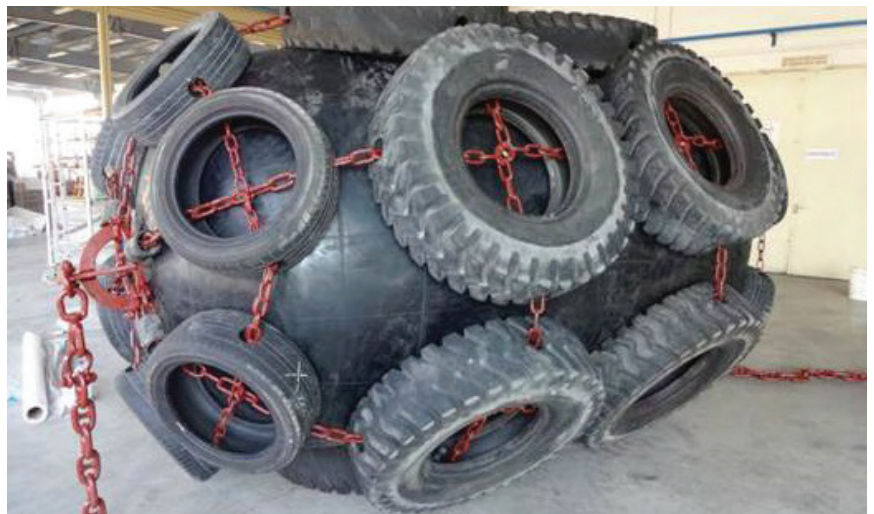
*Yokohama fender repaired with Belzona*

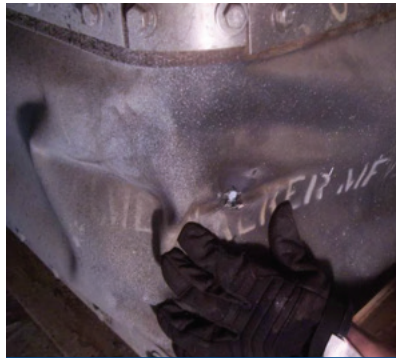
*Ripped bellows*

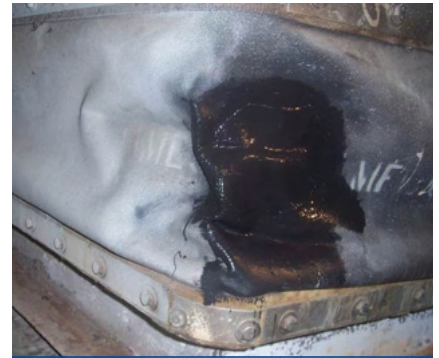
*Localised repair*

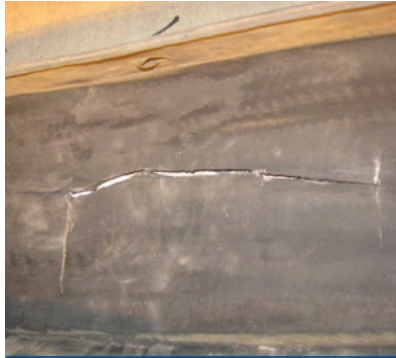
*Cracked expansion gasket*

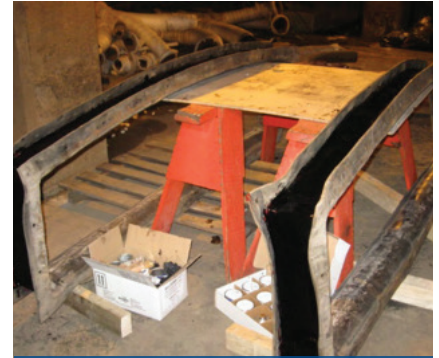
*Repair completed*

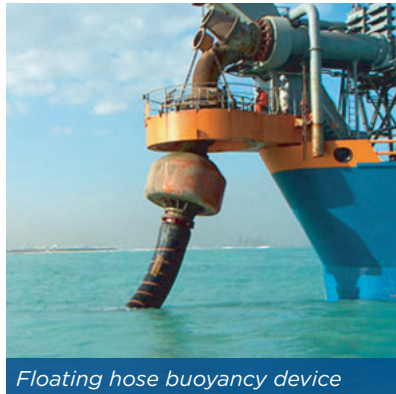
*Floating hose buoyancy device*

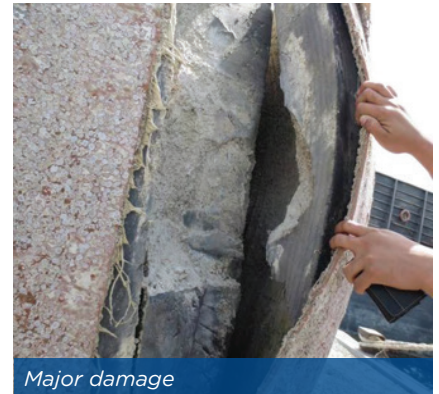
*Major damage*

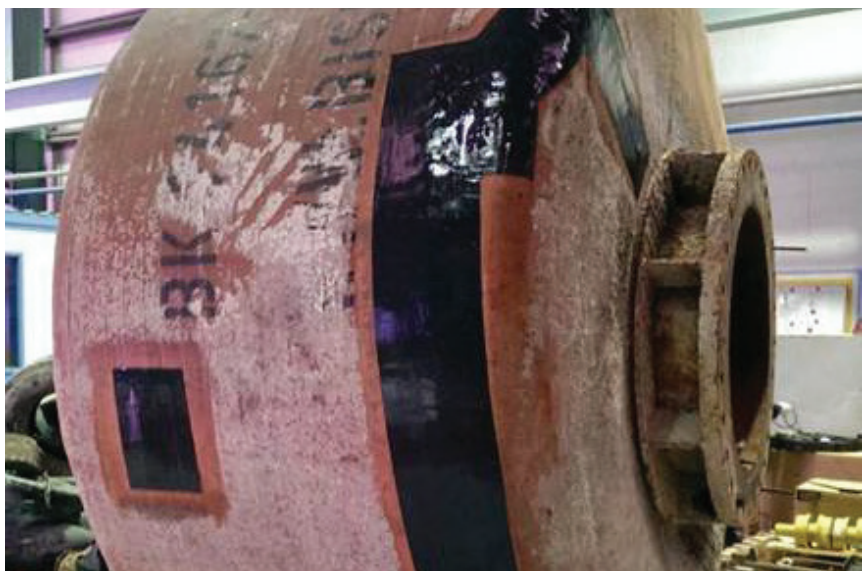
*Damaged areas repaired*
