ASSET INTEGRITY AND HIGH PERFORMANCE IN PETROCHEMICAL FACILITIES

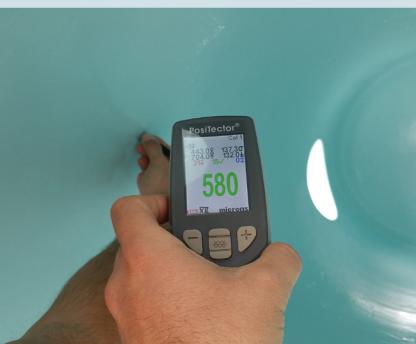
INTERNAL LINING PROTECTED

**TYPICAL PROBLEMS:** Interior linings are susceptible to erosion and corrosion through constant attack from chemical solutions, accelerated by elevated temperatures and entrained solids. Deteriorated process vessel flanges and nozzles subsequently lead to corrosion and leaks.

**POTENTIAL SOLUTIONS:** Belzona 1000, 4000 and 5000 series paste- and fluid-grade materials for metal rebuilding and erosion-corrosion protection even at high operating temperatures. Complete vessel protection can be achieved through nozzle inserts and flange face forming, restoring damage and protecting against corrosion.

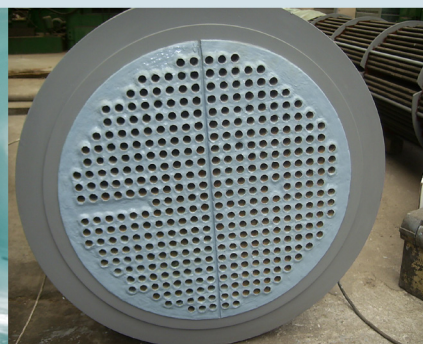
HEAT EXCHANGER RENEWED

**TYPICAL PROBLEMS:** Areas such as tube sheets, water boxes, flange faces, division bars and end covers can be damaged by erosion, galvanic corrosion, crevice corrosion and chemical attack.

**POTENTIAL SOLUTIONS:** Belzona 1000, 2000, 4000 and 5000 series offer a wide range of cold curing metal repair composites and epoxy coatings to restore deteriorated surfaces and provide long-term erosion and corrosion protection with high temperature resistance.

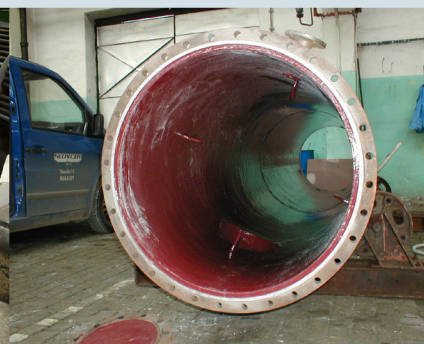
NEUTRALIZATION TOWER LIFE EXTENDED

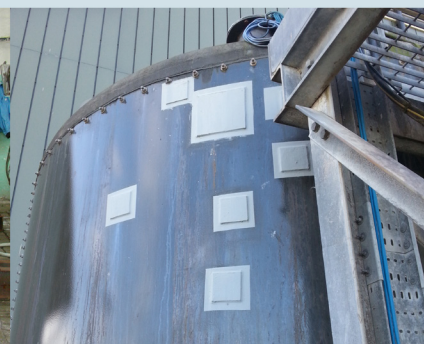
TANK WALL REPAIRED

**TYPICAL PROBLEMS:** Issues such as: tank base corrosion, interior linings affected by erosion, corrosion and chemical attack, external corrosion by weathering, corrosion under insulation, wall defects leading to leaks as well as UV and acid rain attack.

**POTENTIAL SOLUTIONS:** Belzona 1000, 2000, 3000, 4000, 5000 and 6000 series paste- and fluid-grade materials offering cold-applied repair solutions, long-term protection both internally and externally with a resistance to a wide range of chemicals and environmental damage, leak sealing, tank base sealing and cold bonding to tanks walls and roofs.

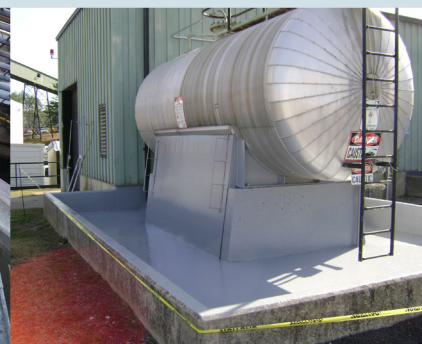
CHEMICAL CONTAINMENT PROTECTED

**TYPICAL PROBLEMS:** Deterioration of containment area as well as mechanical or structural damage caused by: acid attack, pH reduction, carbonation, sulphate attack, caustic attack, microbial degradation, corrosion of reinforcement and abrasive wear. Breakdown of the concrete can lead to a loss of integrity and strength, increased porosity and environmental risks.

**POTENTIAL SOLUTIONS:** Belzona 4000 series materials for the repair and protection of concrete subject to abrasion, impact, and chemical attack such as concentrated acids. Belzona 5800 series for protection from physical, chemical, or bacterial attack in a diverse range of environments.

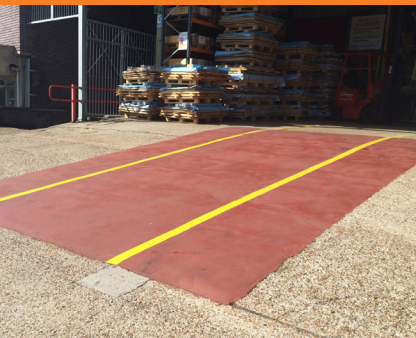
LOADING AREA PRESERVED

**TYPICAL PROBLEMS:** Damage and deterioration to concrete including areas such as: floor areas, expansion joints, spalling concrete, stair treads, channels, dry joints and gratings caused by chemical attack, physical impact, freeze-thaw and expansion joint failure.

**POTENTIAL SOLUTIONS:** Belzona 1000, 2000, 4000 and 5000 series paste- and fluid-grade materials offer concrete restoration and levelling, expansion joint repairs, floor slip resistance and safety markings.

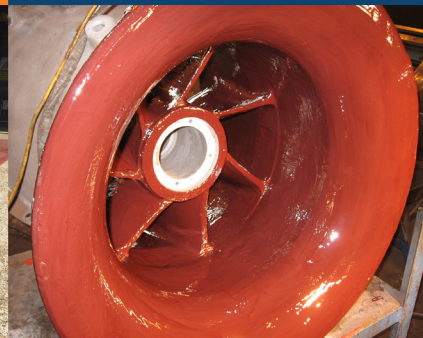
VERTICAL PUMP RESTORED

**TYPICAL PROBLEMS:** Prolonged exposure to erosion, corrosion, chemical attack, wear and cavitation, reducing the performance of the pump or leading to deterioration.

**POTENTIAL SOLUTIONS:** Belzona 1000, 2000, 4000 and 7000 series paste/fluid grade materials and coatings for the rebuilding of surfaces, long term corrosion and erosion protection, shaft repairs, wear ring reseating, pourable chocking for precise alignment and the increase of pump efficiency.

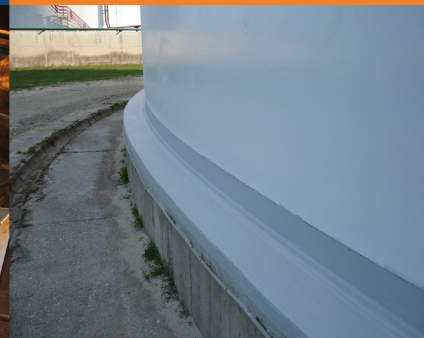
TANK BASE SEALED

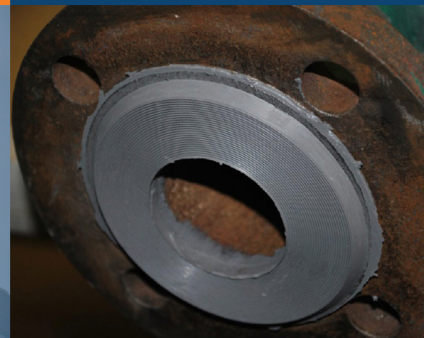
FLANGE FACE FORMED

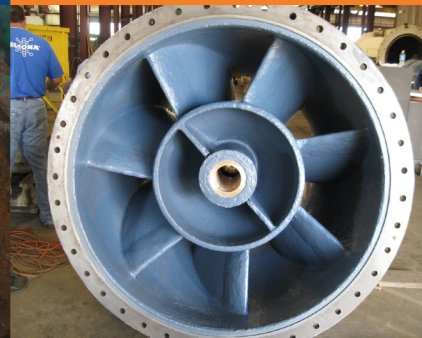
CENTRIFUGAL PUMP RESTORED
