# Emergency Pipe Leak Repairs, up to 10Bar Pressure

A range of solutions are available for emergency live and offline leak repairs, which ensure quick return to service and lasting performance.

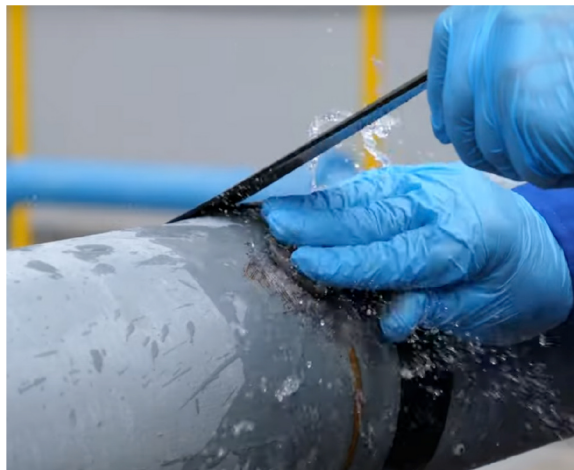
Leak sealed with Belzona 9611

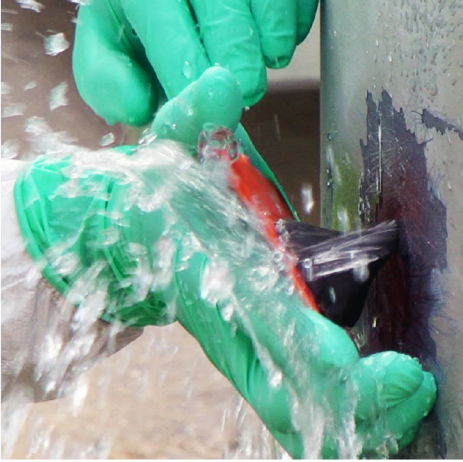
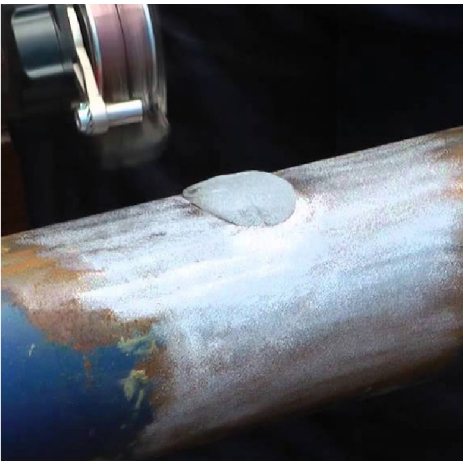
Some low-pressure live leaks must be stopped instantly, due to Health & Safety issues or potential loss of production.

**Belzona 9611** can stop a leak up to 2Bar instantly and act as a bespoke plug. The system should then be wrapped or have a doubler plate bonded for continuous increased pressure retention.

Mouldable fast-curing plug, which temporarily stops the leak. Used with a suitable Belzona paste grade.

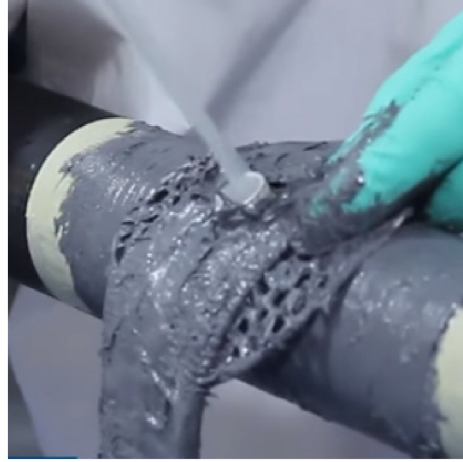
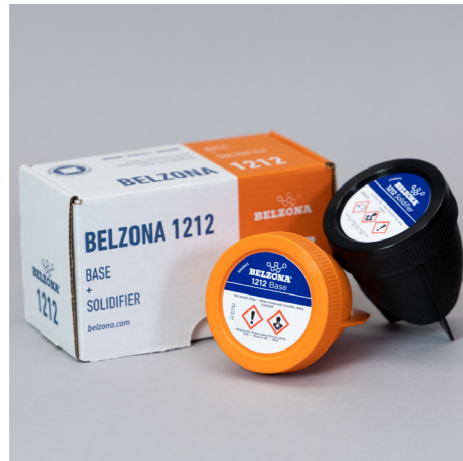
Higher pressure live leak repairs (up to 10Bar) required a prefabricated bypass plate, which could be time consuming and costly.

**Belzona 9621**, a 3D-printed mesh kit, used in conjunction with Belzona 1212, eliminates the need for a prefabricated bypass plate, moulding over straight pipes of various diameters.

3D-printed mesh kit, used in conjunction with Belzona 1212 for live leak sealing.

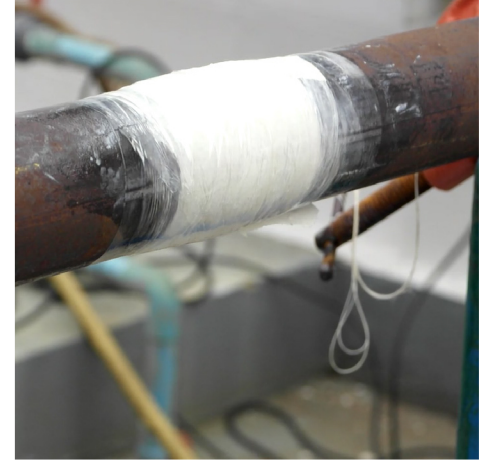
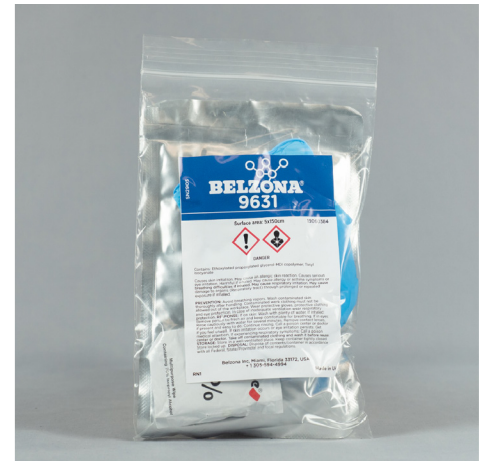
Low pressure pipes, which can remain offline for the duration of the application and require the simplest application methods.

**Belzona 9631** can be used to seal the leak offline. No mixing is required, as the wrap is pre-impregnated with resin. Repairs up to 5Bar can be completed in less than 30 minutes.

Water-activated wrap kit for offline pipe leak repairs.
