# Belzona SuperWrap II

## ISO / ASME COMPLIANT COMPOSITE REPAIR SYSTEM

*Composite repair system to restore the strength of holed, weakened and corroded pipe and tank walls. Belzona SuperWrap II is comprised of a fluid-grade resin system, a bespoke hybrid reinforcement sheet, based on fibre glass and carbon fibre, as well as a release film to compact and consolidate the application.*

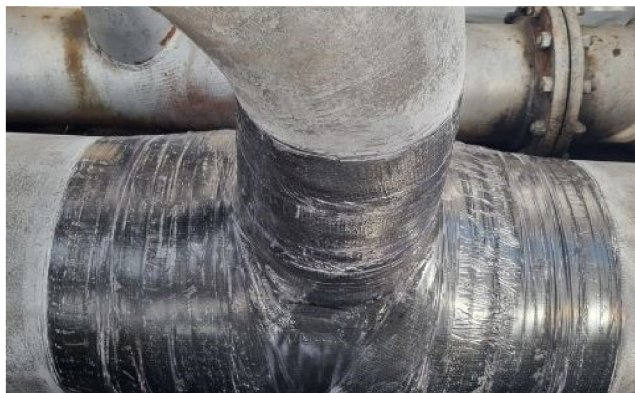
*Belzona SuperWrap II Installed at a refinery*
