# Tank Base Sealing

# Belzona Know-How *in Action*

KHIA ID: 823

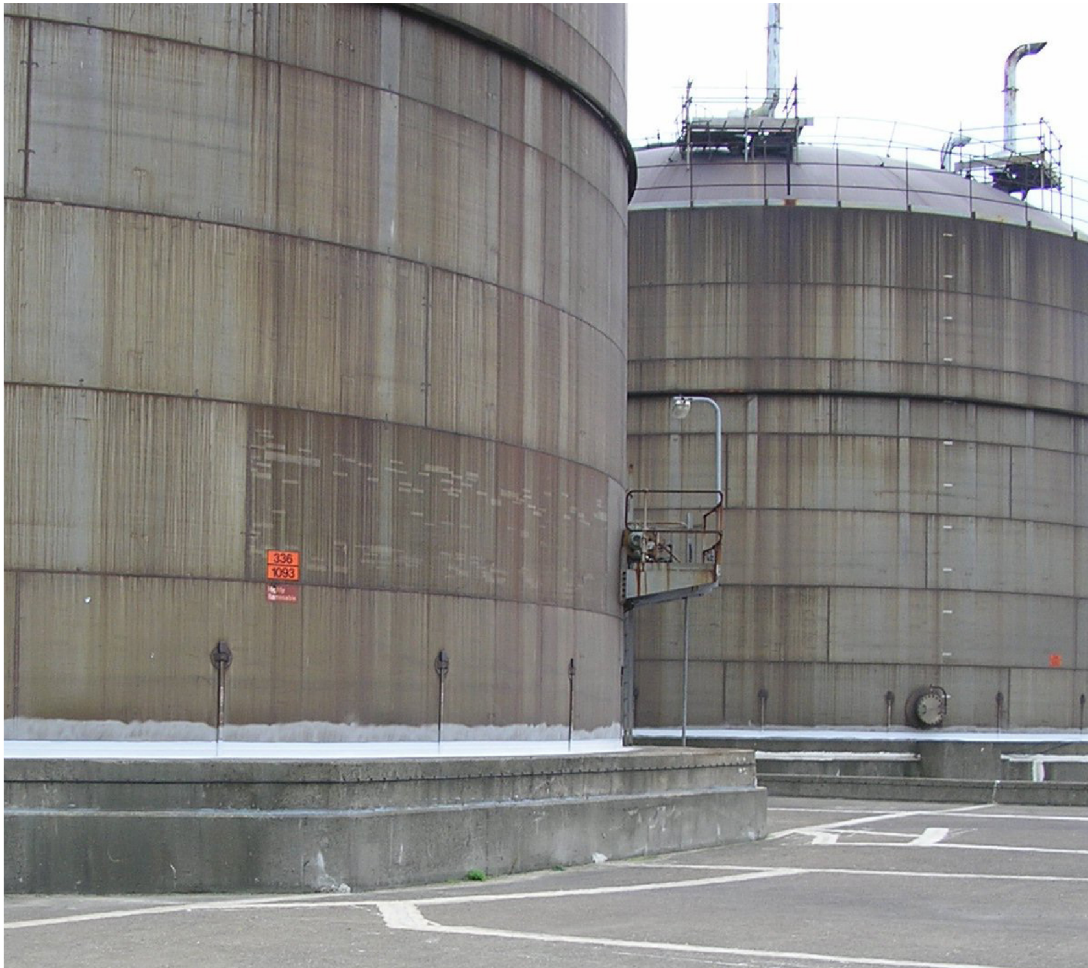
A flexible membrane system in conjunction with a reinforcement sheet encapsulates the circumference of the tank base whilst allowing any residual moisture to permeate through its microporous structure.

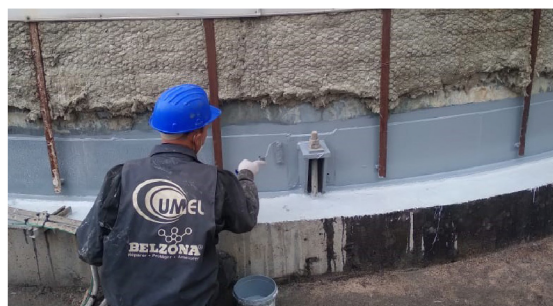
Base of a hydrocarbon storage tank sealed and protected with Belzona.

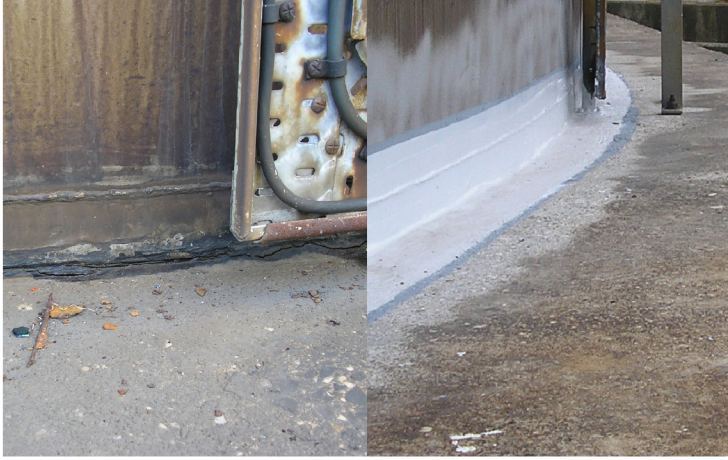
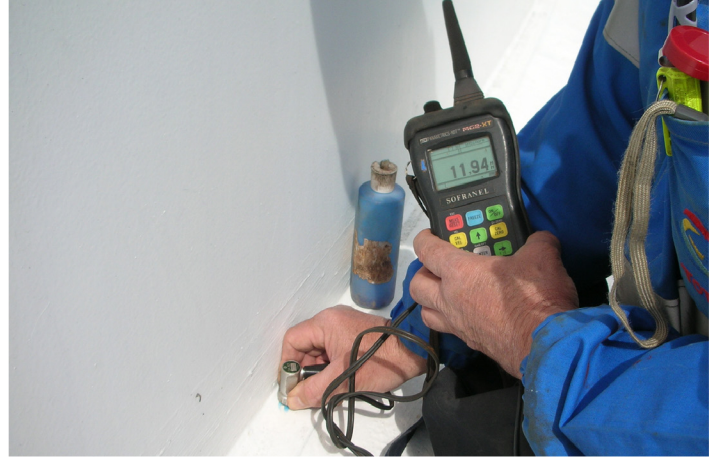
Materials engineers on-site had highlighted that a stress corrosion cracking environment could be created if water was allowed to ingress under the tank floor.

Belzona 3111 (Flexible Membrane) was applied to eight of their carbon steel tanks and three stainless steel tanks.

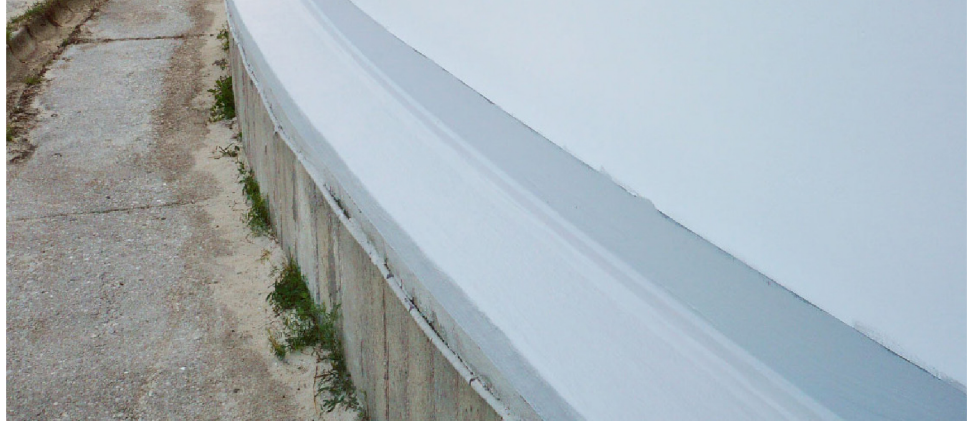
After continuously having to reapply failing tank base sealing systems, this tank refinery installed a Belzona membrane. Following inspection after 13 years in service, the Belzona system was found to be in excellent condition.

Annular ring non-destructive inspection is possible through the membrane without needing to break it.
